# Manhole Inspection Summary

Manhole # S06YY1008MH

Insp Date: **6/28/06 11:24 AM**

**Location** Address: **6819 REISTERSTOWN RD**

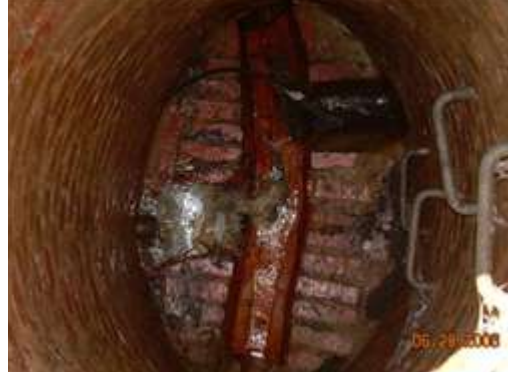
Top View

Adjsutment infiltration. Bench debris.  
Channel debris.

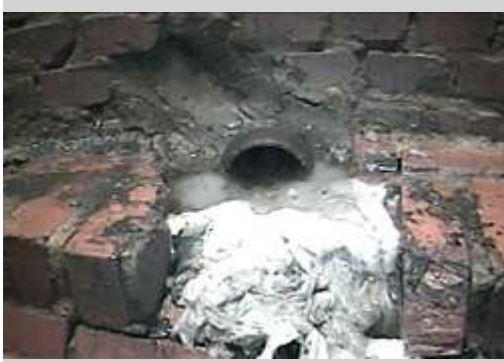
Defect

Comments **The Channel debris picture shows Barrel deterioration and infiltration.**

Condition: ☐ Sound ☐ Cracked ☐ Root Intrusion ☐ Loose Brick ☒ **Deteriorated**

Infiltration: ☐ None ☐ Joint ☐ Cracks ☒ **Mortar** ☐ Roots ☒ **Wall**

Channel debris

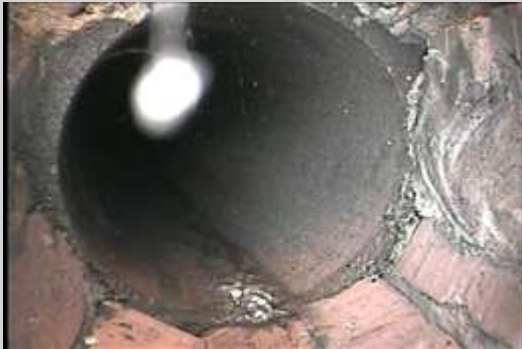
### 8 in. Circular Gravity Sewer Pipe Out @ 12 O'Clock

Infiltration: **Evidence** Pipe Seal Cond: **Unknown**

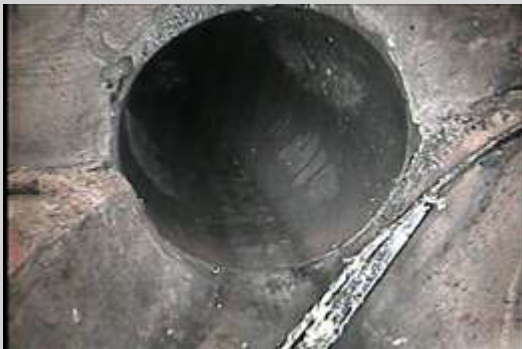
### 8 in. Circular Gravity Sewer Pipe In @ 3 O'Clock

Infiltration: **Evidence** Pipe Seal Cond: **Cracked**

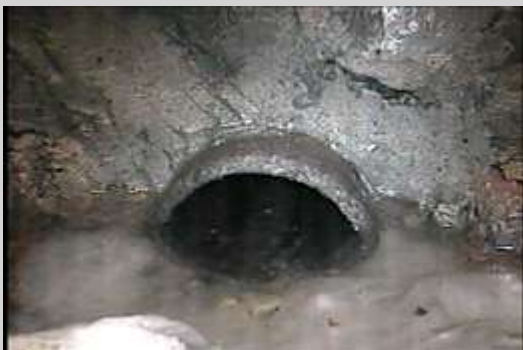
Pipe In @ 9 O'Clock

Deposits: ☐ None ☐ Mud ☐ Sludge ☒ **Debris** ☐ Grease

Silt Depth: **2** (in.) Deposits Extent: **Heavy**
